# Manhole Inspection Summary

Manhole # S13II\_020MH

Insp Date: **2/24/09 9:30 AM**

**Location** Address: **REAR 1800 ASHBURTON ST** Cross Street: **PRESBURY ST**

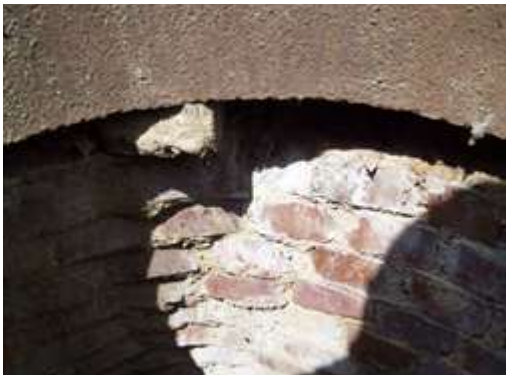
Defect 2

Condition: ☐ Sound ☒ **Cracked** ☐ Root Intrusion ☒ **Loose Brick** ☐ Deteriorated

cracked chimney loose bricks

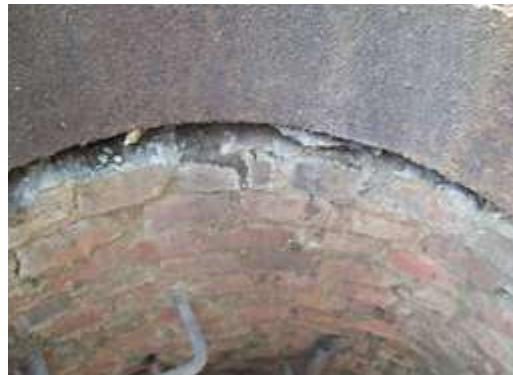
Defect 1

cracked chimney

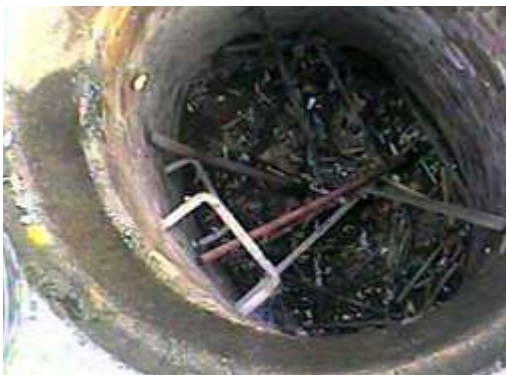
Defect 4

Condition: ☐ Sound ☐ Cracked ☐ Root Intrusion ☐ Deteriorated ☐ Leaks ☒ **Debris**

debris in the channel

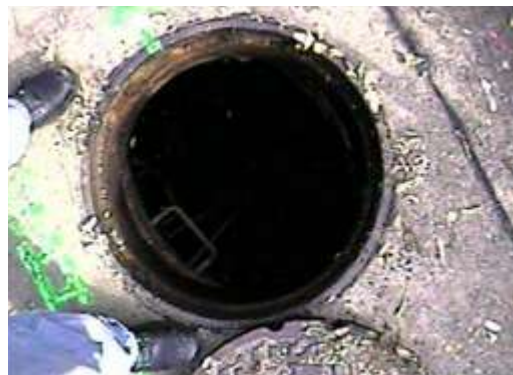
Defect 3

**Steps** Count: **2** Missing: **0** ☒ **Corroded**

corroded steps

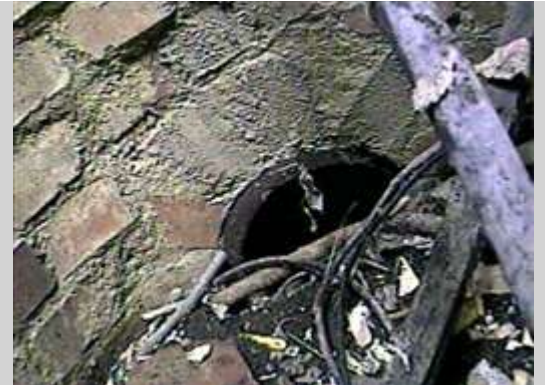
12 O'Clock Outflow

8 in. Circular Gravity Sewer  
Pipe Out @ 12 O'Clock

Pipe Material: **Clay** ☐ Pipe Lined

Invert Depth: **5.07** (ft.) Flow Characteristics: **None**

Infiltration: **None** Pipe Seal Cond: **Sound**
